Dam ID: HI00063
Aahoaka Reservoir

Inspection No: _____
Date: 3/21/2006

STATE OF HAWAII - DLNR
VISUAL DAM SAFETY INSPECTION SHEET

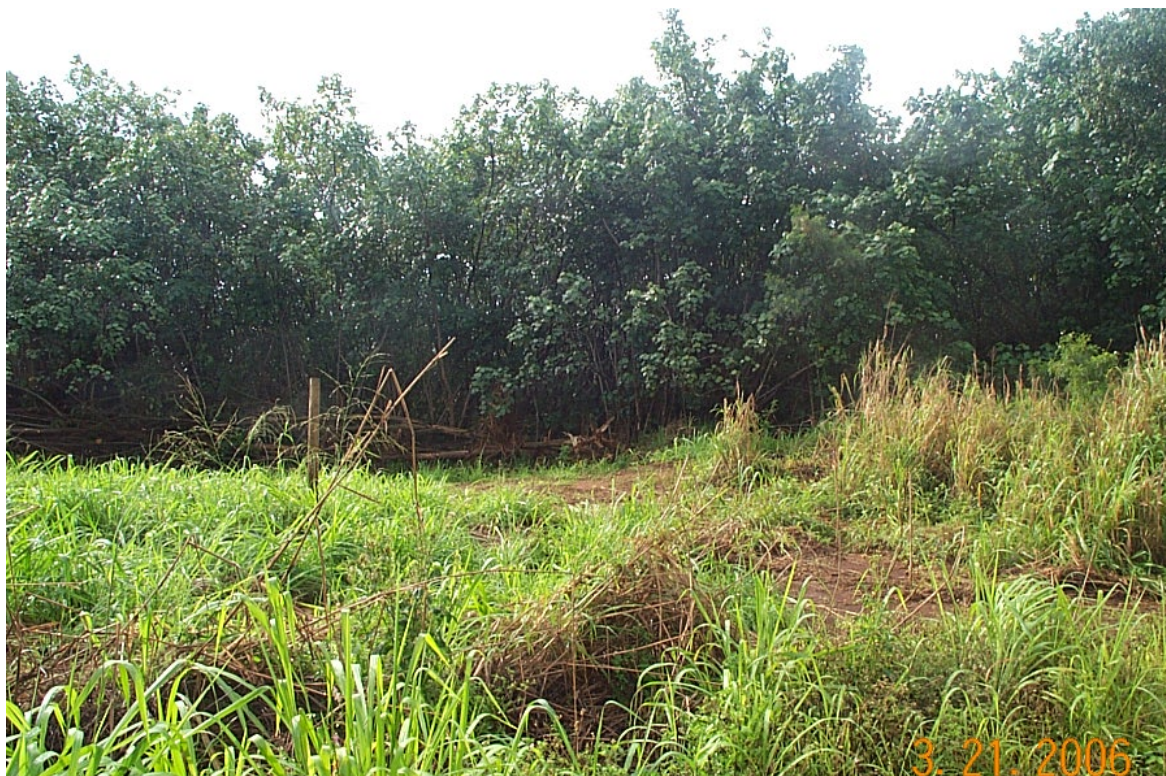
Description: Lots of trees in spillway exit channel about 100' D/S of sill.

HI00063 - Aahoaka Reservoir: Spillway exit channel. Note the trees in the exit channel.

1. Remove trees in the spillway exit channel. Debris is prone to catch on the trees and block the spillway from functioning as designed.
2. The upstream and downstream slopes of the embankment should be clear and visible for inspection. Underbrush should be cleared and grasses kept short. Trees have been allowed to grow so large in some cases that there is concern that seepage along the root systems may develop. There is additional concern that cutting and killing the trees will lead to rotten roots and greater potential for seepage. A more in depth evaluation of the vegetation conditions should be performed to determine how best to remediate the condition.

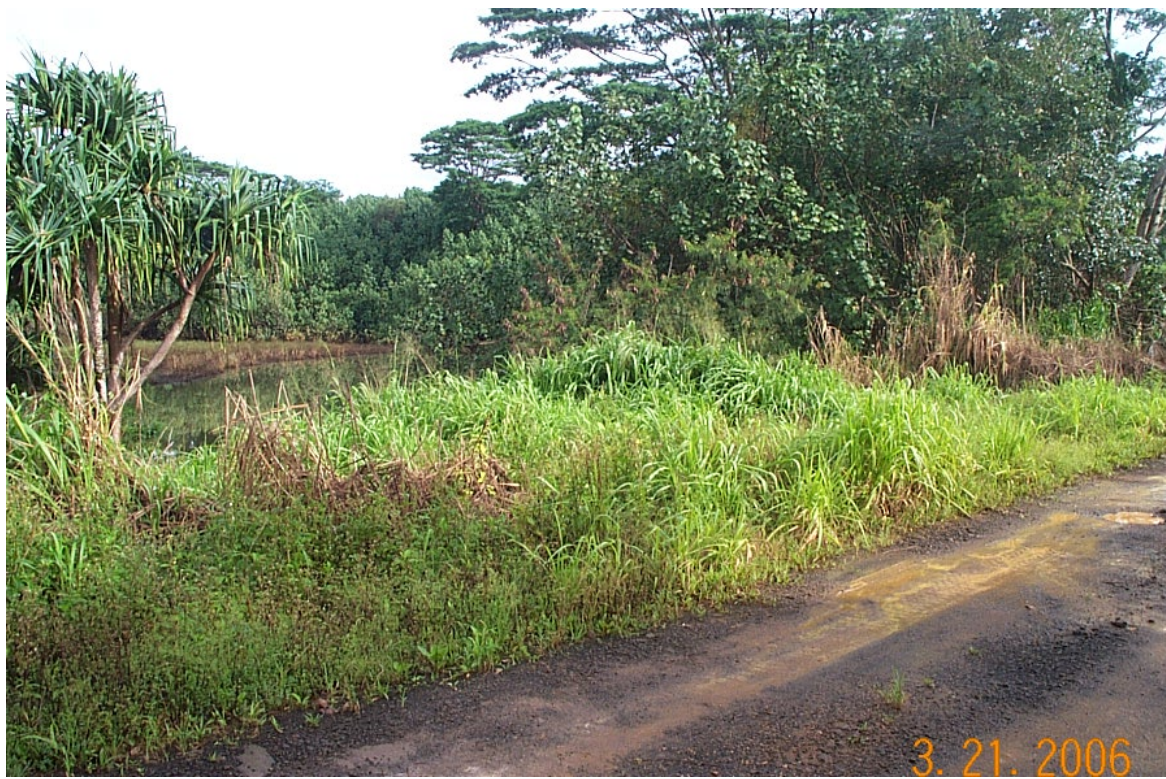
Approach: ☐ Clear ☒ High Veg. ☐ Trees ☐ Other: _____

HI00063 - Aahoaka Reservoir: Vegetation in the spillway approach channel.

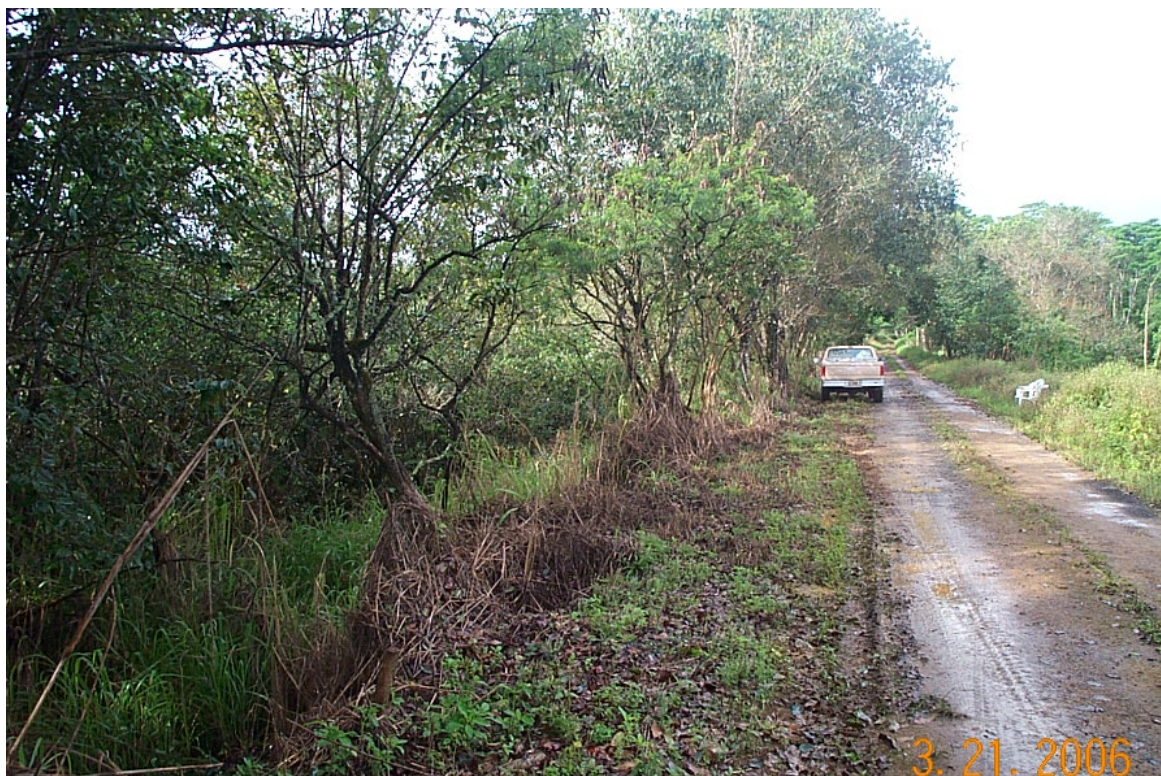
Vegetation: ☐ None ☐ Low Ground Cover ☒ Bushes or Tall Grass ☒ Trees # lots ☐ <6" ☒ >6" & <20" ☐ >20"Description: Difficult to inspect the slope because of vegetation.Seepage: Seep Spot Number 1☐ Green Vegetation ☐ Wet or Muddy Ground ☐ Ponding Water ☐ Not Visible ☒ None Observed☐ Flowing, Description: _____Water Clarity: ☐ Clear ☐ Some particles ☐ Muddy ☐ Other: _____

- ☒ j. The slope was very steep, around a 1 to 1 slope, further study is required to verify slope stability.
- ☐ k. _____

HI00063 - Aahoaka Reservoir: View of downstream slope and crest. Note the dense vegetation on the slope.

- ☐ h. A sinkhole was observed on the slope, which requires further investigation to determine the underlining cause. Repair and monitor the area.
- ☒ i. The down stream slope was not visible due to high grass and bush vegetation. Clear high vegetation and maintain low to enable easy visual inspection.

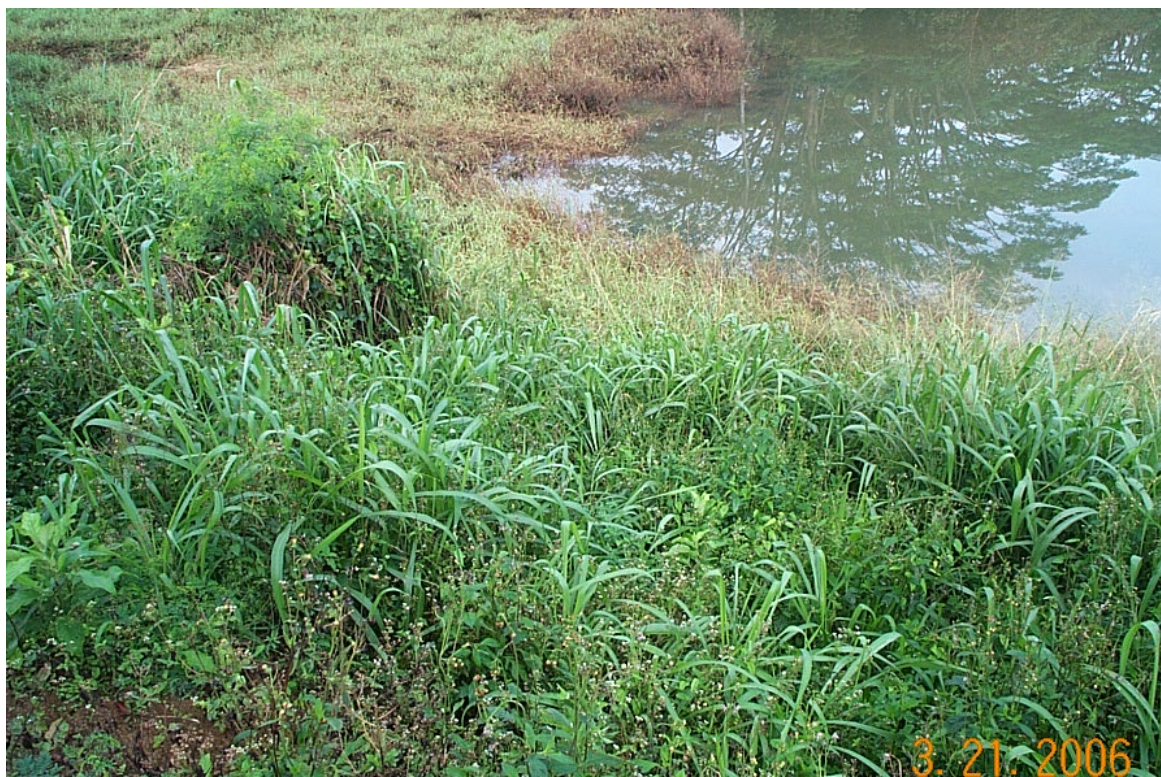
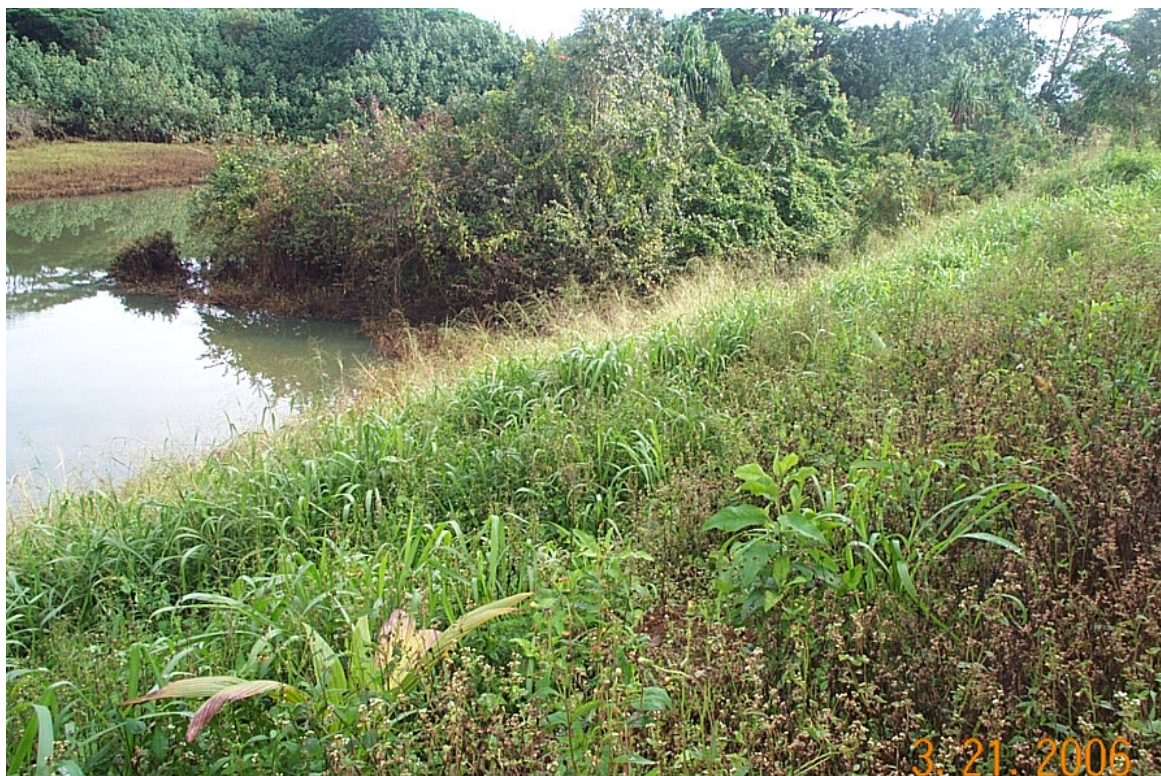
Description: Entire face covered with 2' to 3' tall grass and vegetation

*** - Upper 10' of slope is very steep (1V:1/2H), lower slope is flatter (1V:2H). It's unknown if the steep upper slope occurred due to erosion, sloughing, or if it is excess material that was pushed over the edge of the crest during road grading activities.**

HI00063 - Aahoaka Reservoir: View of the upstream slope with vegetation.

- ☐ h. A sinkhole was observed on the slope, which requires further investigation to determine the underlining cause. Repair and monitor the area.
- ☒ i. The upstream slope was not visible due to high grass and bush vegetation. Clear high vegetation and maintain low to enable easy visual inspection.

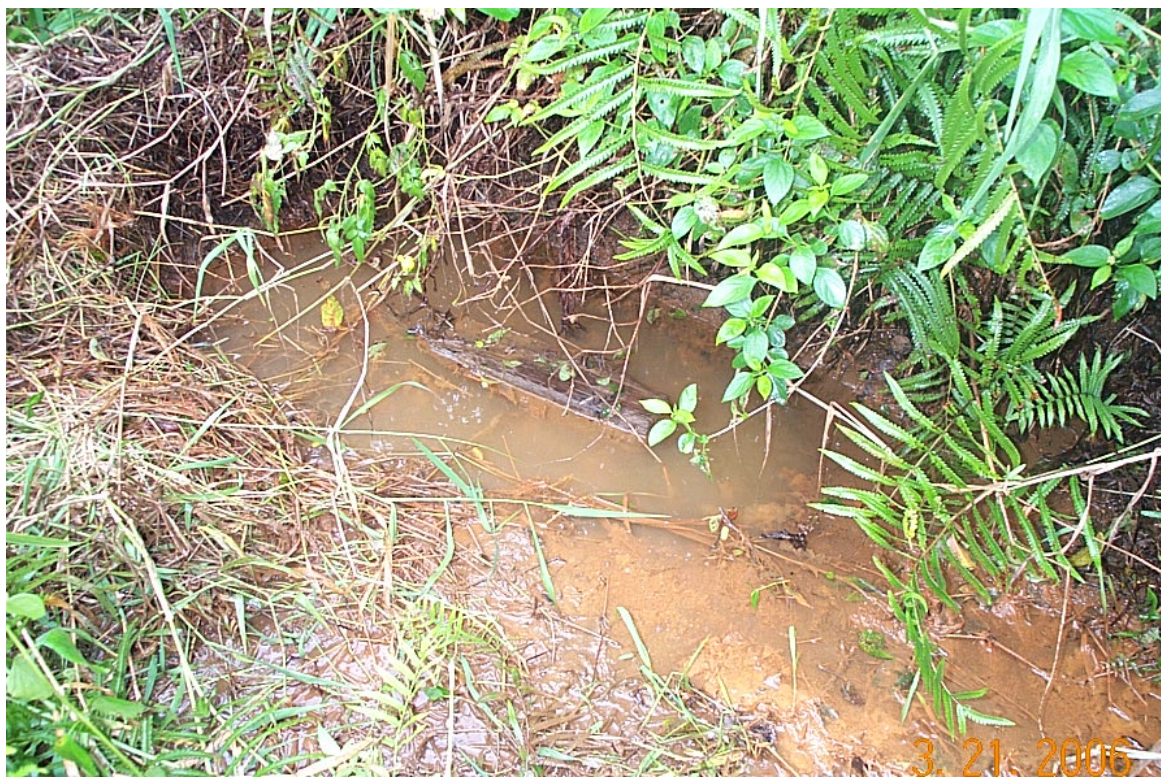
Seepage: Seep Spot Number 1
☐ Green Vegetation ☒ Wet or Muddy Ground ☒ Ponding Water ☐ Not Visible ☐ None Observed
☒ Flowing, Description: Flowrate of 10 gpm on the right side of the valley bottom.
 Water Clarity: ☒ Clear ☐ Some particles ☐ Muddy ☐ Other: _____
 Description: Seepage was clear. Seeping has been occurring for a while because of alge growth. No imminent threat of dam failure from the current seepage conditions. Dam owner should monitor seepage when pool elevation increases.

Seep Spot Number 2
☐ Green Vegetation ☐ Wet or Muddy Ground ☒ Ponding Water ☐ Not Visible ☐ None Observed
☐ Flowing, Description: seepage on the right side valley bottom
 Water Clarity: ☐ Clear ☐ Some particles ☐ Muddy ☐ Other: _____
 Description: Ponded water at valley bottom. Could not find seepage exit points. Water likely from seepage flowing down from the right abutment

HI00063 - Aahoaka Reservoir: Seepage on the right side of the valley floor.

- ☒ j. Seepage/Ponding water was observed. Monitor and conduct further investigation to locate the source of water and extent of any possible hazardous or developing condition.

4. Seepage was observed along the downstream toe of the dam near the right side of the valley floor. The rate of seepage should be measured with a V-notch weir or Parshall flume. The rate of seepage should be measured with respect to the reservoir pool elevation.

5. A seepage study should be conducted by a geotechnical engineer to determine the stability of the dam with regards to seepage in the foundation and through the embankment.
